# Exterior Screening for Seismic System and Age

### D.1 Introduction

### D.3 Identification of Building Age

### **D.4** Identification of Structural Type

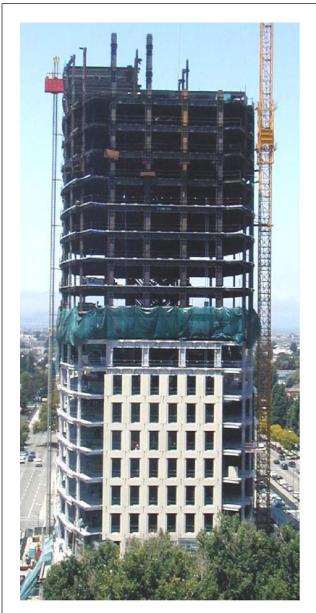
a. Building above is a high-rise steel dual system – moment frame (heavy columns and beams on upper facade) with bracing around elevator core. Fireproofing is being applied to steel at mid-height (inside the shroud) and precast facade elements are being attached to frame in lower stories.

Figure D-1 Photos showing basic construction, in steel-frame buildings and reinforced concrete-frame buildings.

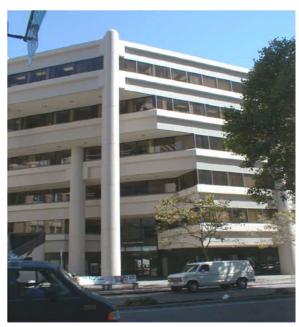
Figure D-2 Building with exterior columns covered with a facade material.

- 1. In newer frame construction the columns are often exposed on the exterior in the first story. If the columns are covered with a facade material, they are most likely steel columns, indicating a steel frame. If the frames are concrete, they are usually exposed and not covered with a facade. See Figures D-2 and D-3.
- 2. Some structures use a combination of shear walls in the transverse direction and frames in the longitudinal direction. This can be seen from the exterior as the shear walls usually extend through the exterior longitudinal wall and are exposed there. This is most common in hotels and other residential structures where balconies are included. See Figure D-4.
- 3. An inspection of doorways and window framing can determine wall thickness. When the thickness exceeds approximately 12 inches, the wall is most likely unreinforced masonry (URM).

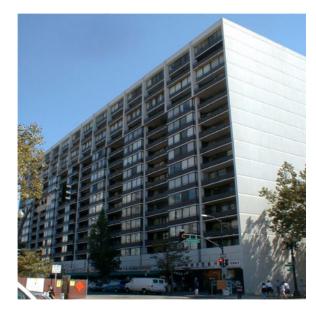
Figure D-4 Building with both shear walls (in the short direction) and frames (in the long direction).

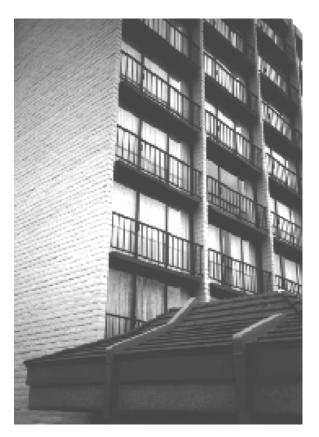
Figure D-7 Reinforced masonry building with exterior wall of concrete masonry units, or concrete blocks.

6. If the exterior wall shows large concrete block units (approximately 8 to 12 inches high and 12 to 16 inches in length), either smooth or rough faced, the structure type may be reinforced concrete block masonry. See Figure D-7.
